# CASE STUDY

## John White for 99 South Ltd - Rurikaka Creek, Orepuki Catchment

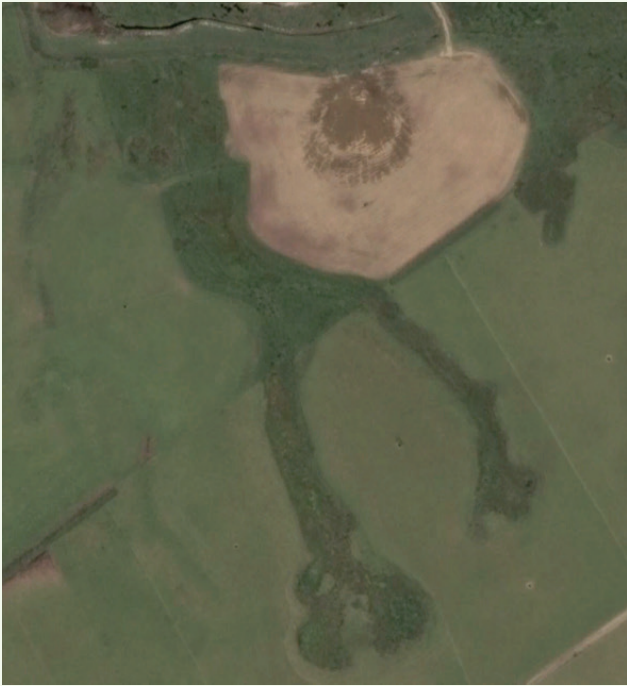
**IMAGE 1:** Aerial photo showing closer detail of site one prior to construction.

The gully areas are visible as the dark green areas at the bottom of the image that join together near the centre of the image. Prior to construction this area had poor drainage and was not considered to be a highly productive area of the property.

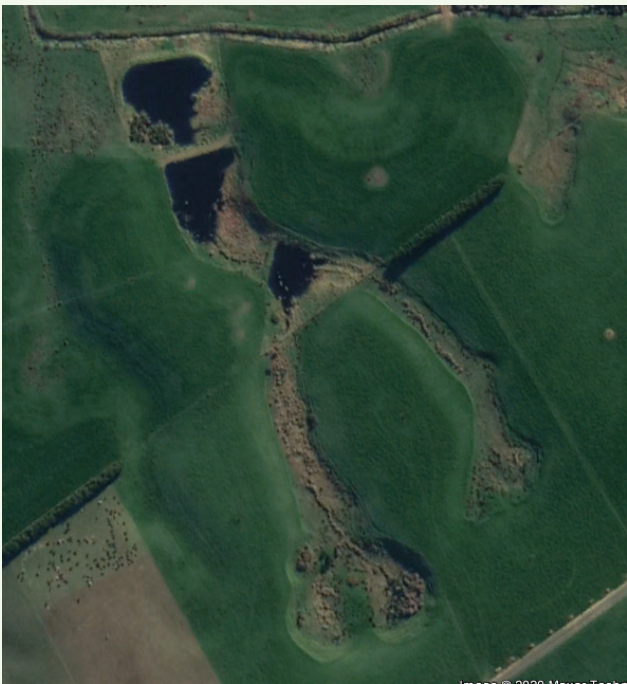
**IMAGE 2:** This image is the same as location as the previous image approximately 4 years after the completion of the sediment trap structures. You can easily see the pond areas where water velocity is slowed to allow suspended sediments to drop.

Site one involved the construction of three sediment trap areas to capture material flowing off a small gully system above. As shown in the images below, you can see that this site includes a series of ponds with an initial receiving area, which then overflows to a second and third ponding areas before being discharged into an adjacent waterway.

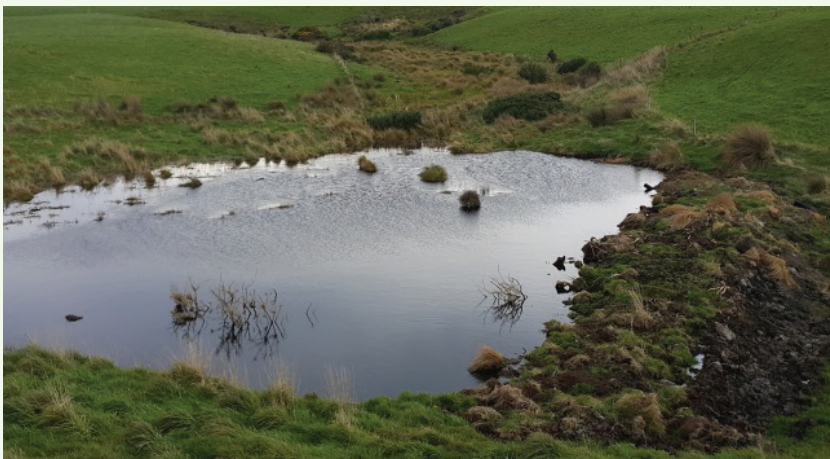
**IMAGE 3:** Facing west, the upper pond area post construction. Note the recently constructed bank to the right of the image.

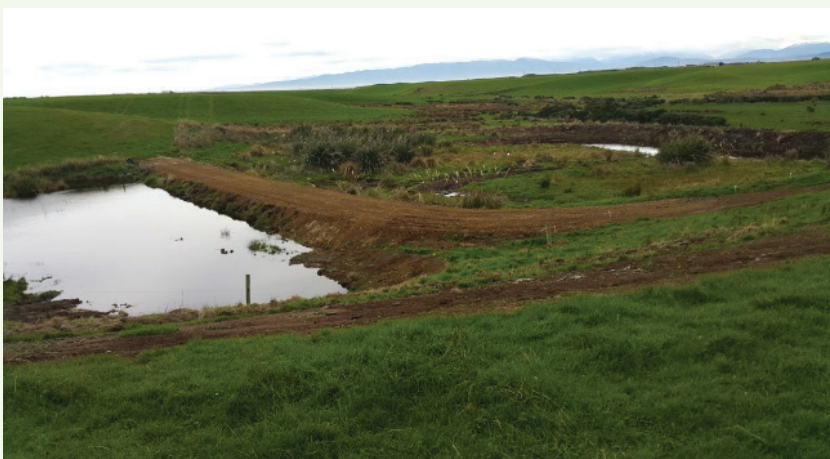
**IMAGE 4:** Looking West, the second pond area can be seen to the left, with the bank in the centre of the image separating ponds two and three.

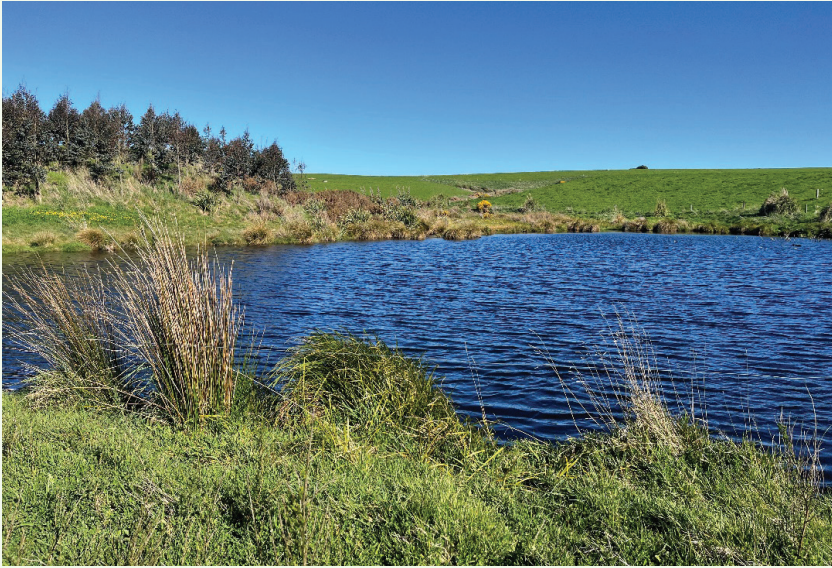
**IMAGE 5:** Standing on the sediment trap bund area between ponds two and three looking south towards the catchment area for this series of sediment traps.

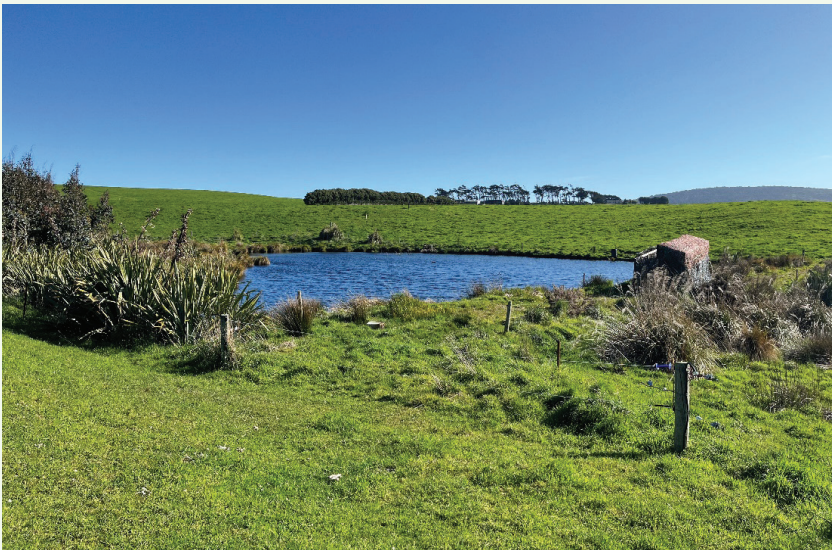
**IMAGE 6:** Looking west at the second pond area. The bank separating the second and third pond is to the right.

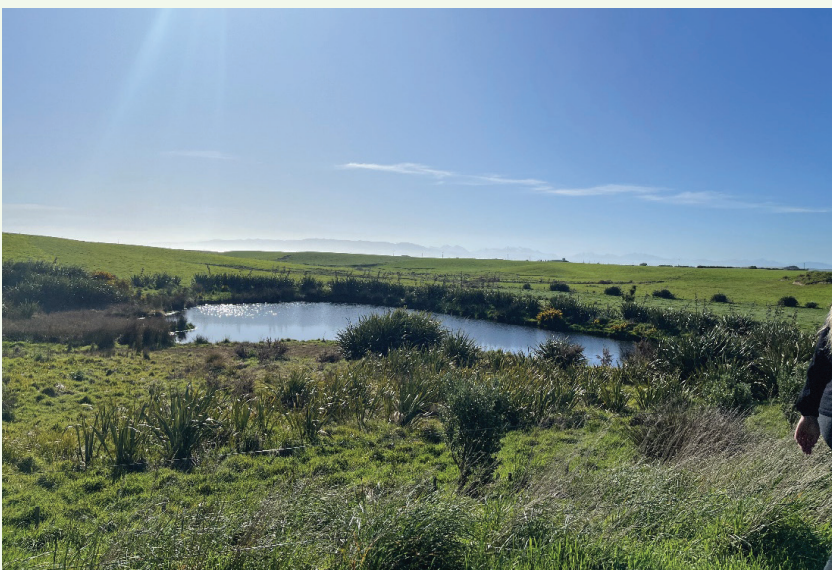
**IMAGE 7:** The third pond area looking north west. Water flows out of this final pond via an overflow into an adjacent waterway.

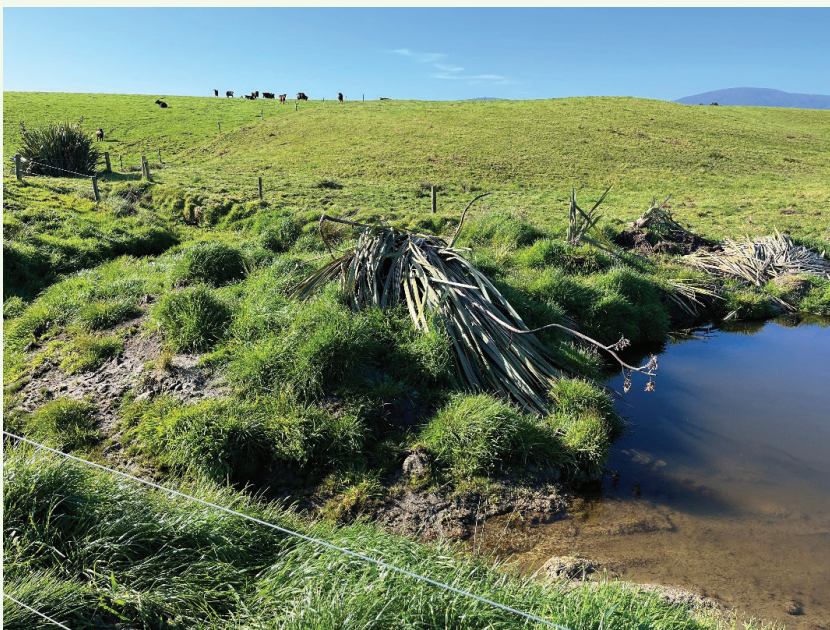
**IMAGE 9:** Bund at the base of the first sediment trap pond area at the top of the catchment. Bund number 1.

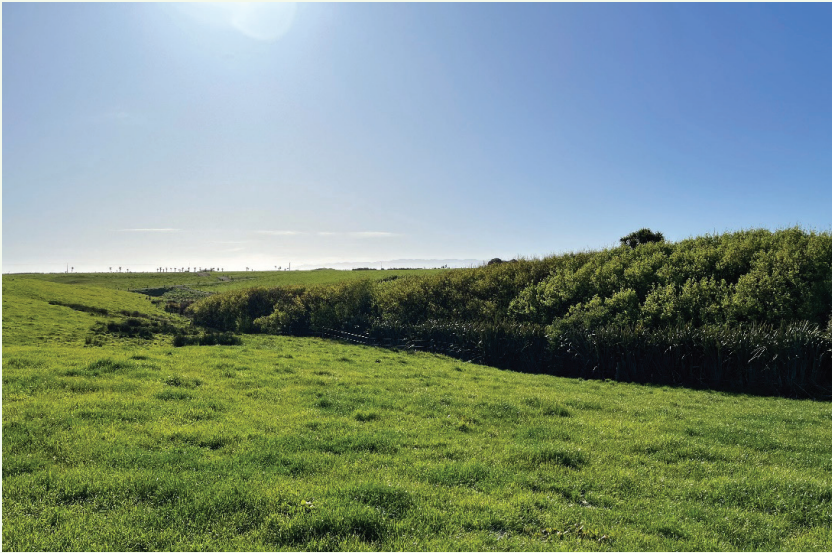
**IMAGE 10:** Well established stand of willows and flaxes capturing sediment.

Within the proposed area, there is a section of established willows that already contains a bunded area and is already effectively capturing sediment. Cleaning sediment out of this area is difficult due to the presence of the thick stand of willows, and is something the landowner may have to consider if this was to be cleaned in the future.

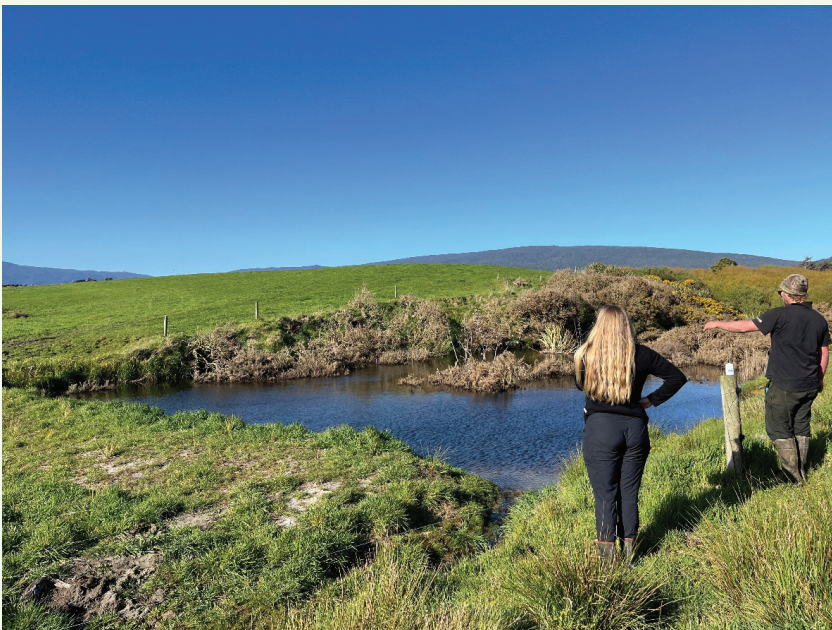
**IMAGE 12:** Bund located to the north of the dairy shed- Image taken during site visit in October 2022. Bank has been planted out in flaxes.

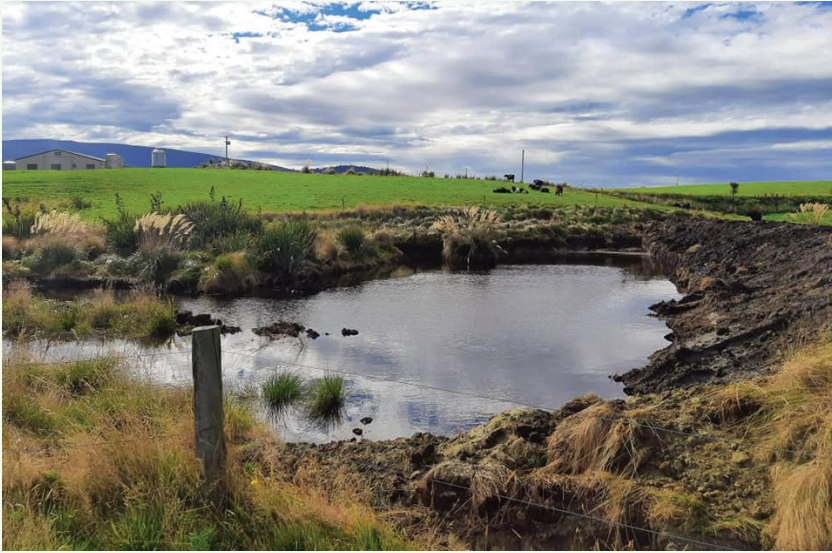
**IMAGE 13:** Bund at the bottom of the catchment immediately post construction looking east – January 2022.

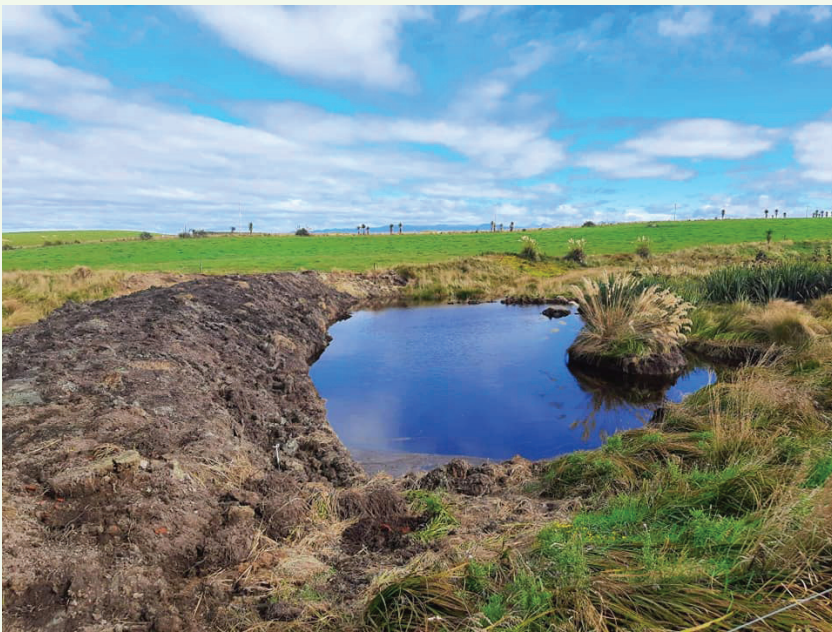
**IMAGE 14:** Bund at the bottom of the catchment immediately post construction looking east – January 2022.

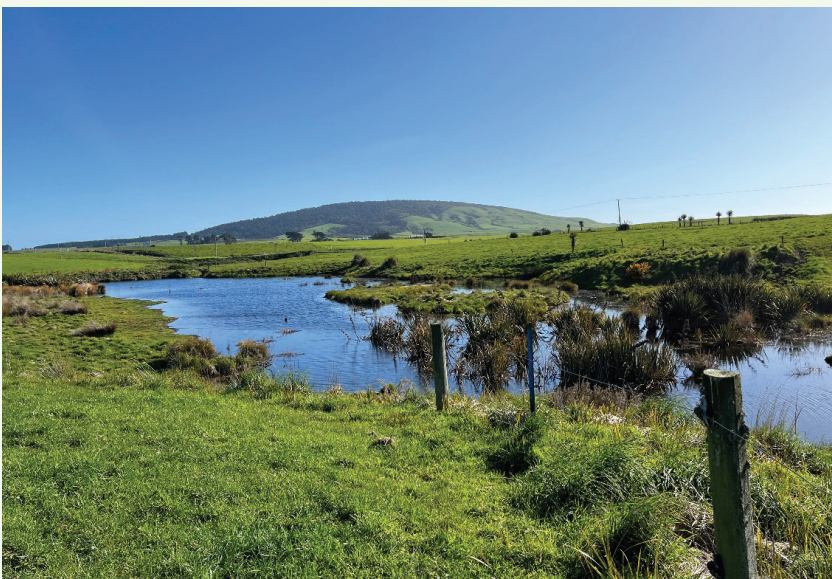
**IMAGE 18:** Looking south towards the downstream/final bund. Vegetation in this area is existing

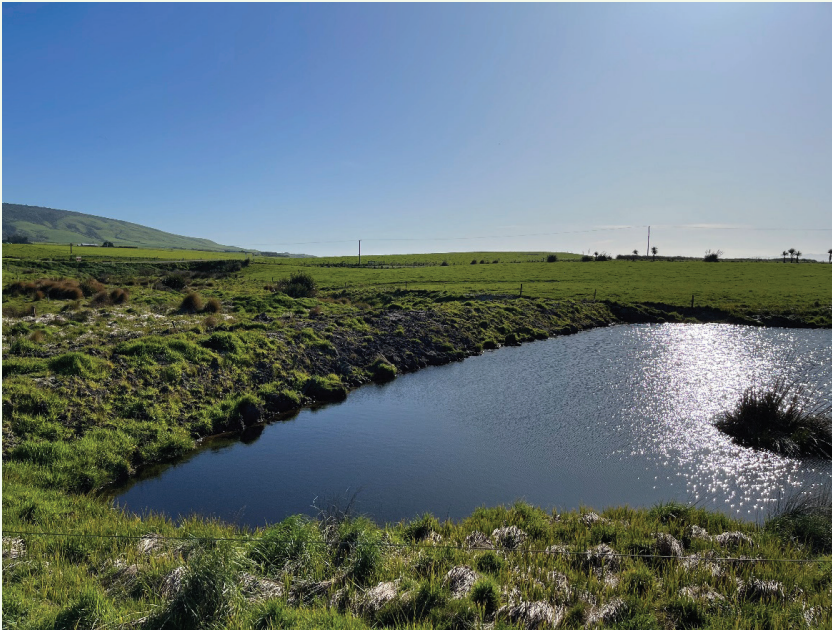
**IMAGE 19:** Bund at the bottom of the catchment looking west during site visit – October 2022
