# Assessment of sites for on-farm pollution mitigation actions

Between the Domes Catchment Group

*Prepared for Thriving Southland*

NIWA CLIENT REPORT No: 2022209HN  
Report date: July 2022  
NIWA Project: THS22201

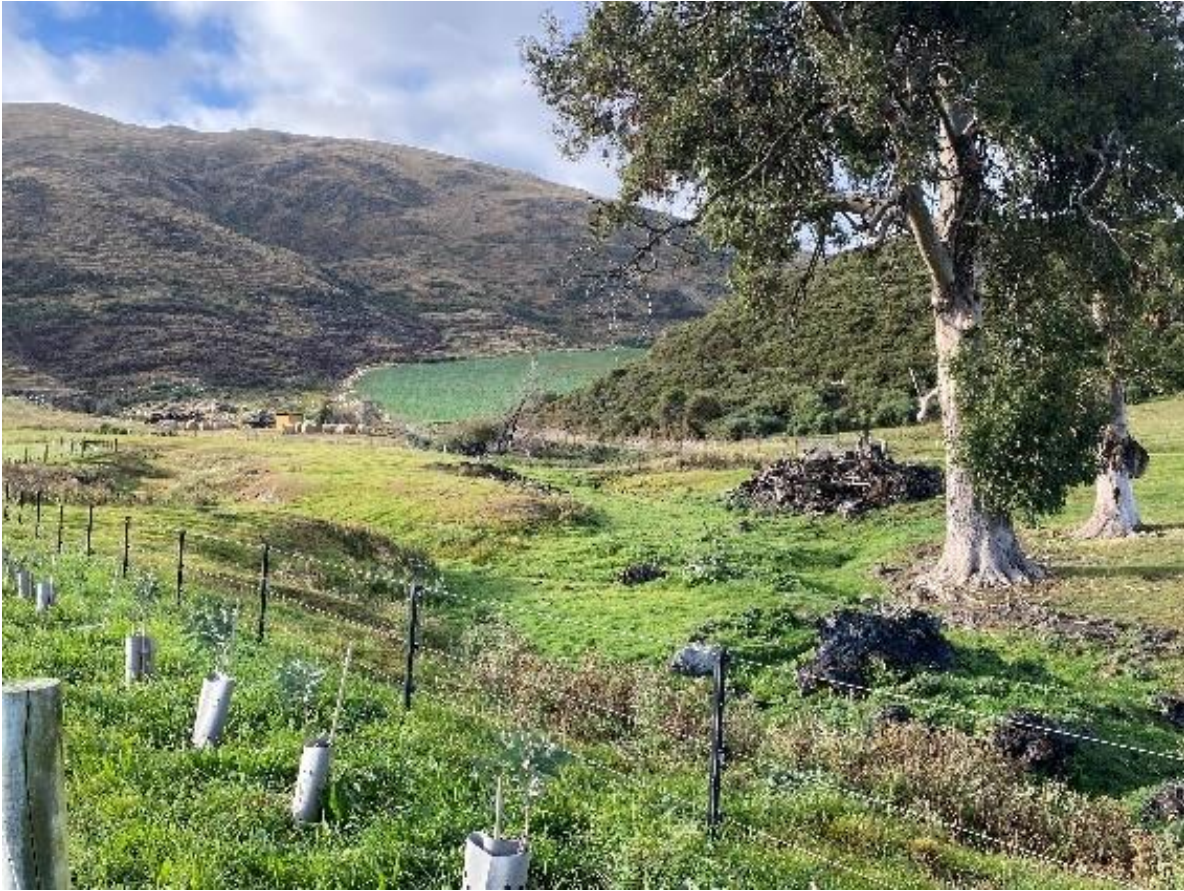
**Figure 3-2: Photo of the potential remediation site looking upstream.**

**Site current status:** Undeveloped stream channel with riparian grass, weeds and occasional sedges. The channel is 0.5-2.0 m wide with perennial flow. The landowners note consistent stream flows of 1-2 L/s in summer, with up to 10 L/s baseflow in winter. Large events occur at a frequency of 5-10 years with much higher flows. Rain >100 mm noticeably increases flows. The contributing area comprises approximately 60-70 ha of hill country and 20 ha of toe-slope terrace (some of which is used for cropping), although most of the catchment has a low degree of pasture development, being scrubby with large areas of bare rock. Some areas of the stream are fully fenced.

**Priority Pollutants:** Fine silts (N and P).

The contributing catchment is steep and prone to erosion during high flow events. The area of cropping on a neighbouring property means nutrient losses from that property also need to be considered when selecting an appropriate remediation tool.

**Potential site re-development:** Multi-stage impoundments stepped down the valley in combination with riparian planting and fencing. Impoundment depths need to be sufficient to trap sediments, with riparian planting on their margins used to help stabilise trapped sediments and resist erosion within the broader channel margins. The stream channel is subject to flashy flood flows from upland hills. Structures constructed in the channel will be at risk of damage during high flows.

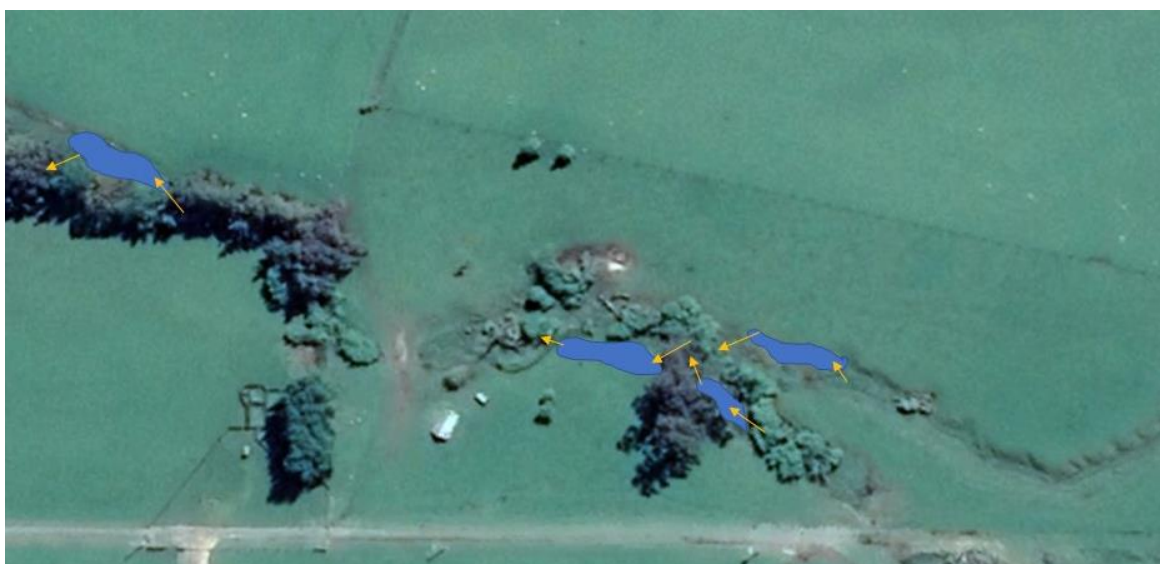
**Figure 3-3: Potential series of off-line sedimentation ponds/wetlands along stream channel.**

**Preliminary remediation concept:** Figure 3-3 shows a potential layout of off-line ponds or wetlands constructed on the edges of the main channel to capture sediment transported in flood flows.

A portion of the mainstream flow can be diverted into the ponds, although very high flows will continue down the existing channel. Offline wetlands/ponds greatly reduce the risk of bund collapse during high flows, do not interfere with fish passage, and in this landscape would be constructed in areas not considered existing wetlands. They are, however, likely to cost more than in-stream impoundments as they require full excavation, rather than modification of the existing flow way. The wetland/ponds with additional riparian planting would enhance habitat diversity, add shading and assist carbon sequestration.

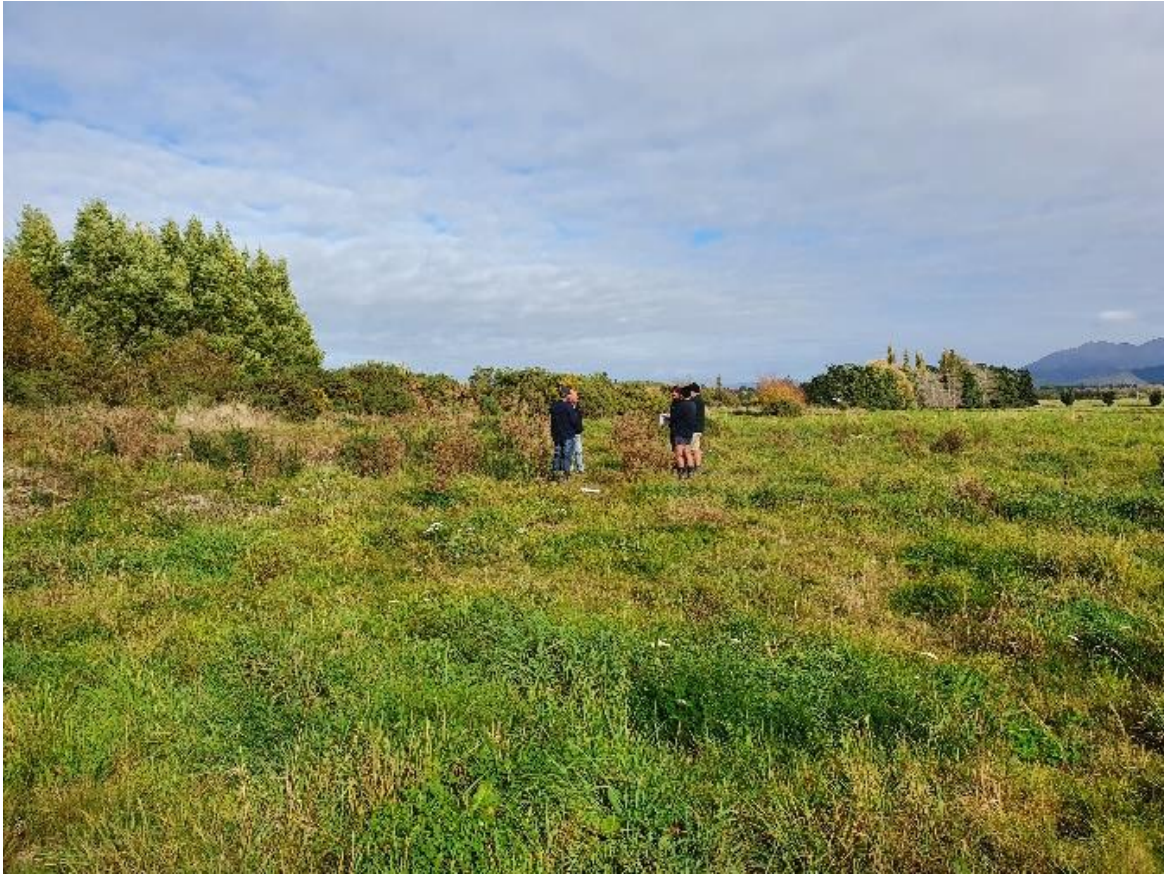
**Figure 3-5: Drummond Farm potential wetland location.**

**Site current status:** The land available is a wet/boggy corner (particularly in winter) of a well-developed grain/cropping farm. The area is largely disconnected from the existing stream (by flood banks and a drainage system). It does not currently show significant wetland characteristics and has ground cover comprising more than 50% exotic pasture species, so would not require protection under the current proposed NPS-FM regulations. The landowners intend to convert upstream surface drains to subsurface drains.

**Priority Pollutants: N & P**

The contributing catchment area is flat and used for cropping, thus nutrients are likely to be the primary pollutant. The farm is not used for stock rearing so faecal contamination is minimal. By “undergrounding” the surface drain, sediment runoff is expected to be minimal.

**Potential site re-development:** The farmer is considering excavating a wetland/pond combination on this site, in part to compensate the environment for the “undergrounding” of upstream surface drains (converting to subsurface tile drains). Options to connect flows from a nearby surface drain about to be “undergrounded” to the proposed wetland/pond were discussed, and generally supported by the farmer. This would increase the quantity of contaminants intercepted by the wetland, improving the potential for water quality benefits. We suggest that the farmer investigate whether a consent is required for the drain modifications, if this has not already been explored.

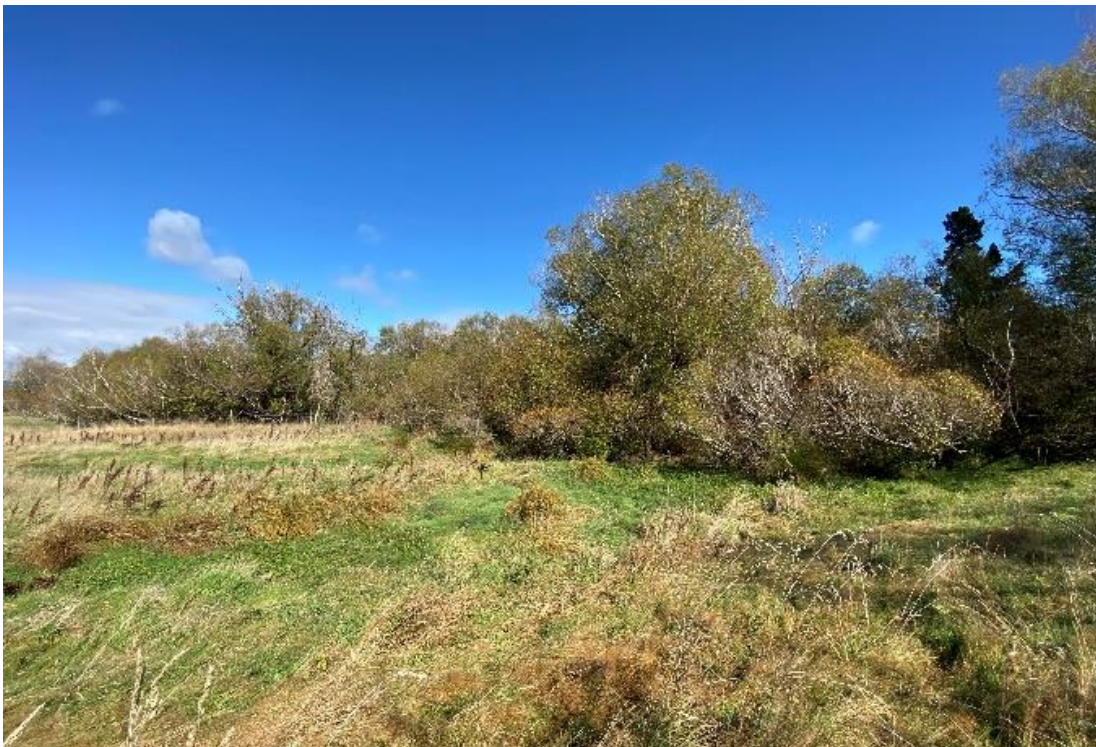
**Figure 3-8: Shirley Farm showing willow dominated natural wetland.**

**Site current status:** Area where several surface drains converge in a willow-dominated natural wetland/stream complex.

**Cons:** The existing willow-dominated area of wetland was very soft underfoot when we visited, with deep, low bulk density organic soils. Access of excavators would likely be difficult. The site is out of public view, limiting its value as a demonstration site.

**Potential site re-development:** The existing wetland area (defined by dashed in the preliminary remediation concept below) and the pond receiving drainage from the upper terrace (to left of photo above) will already be providing water quality and habitat benefits. Excavation within the existing wetland area is likely to be difficult due to the very soft soils, and it may not be permitted if the area meets the definition of a “natural wetland” under the proposed NPS-FM (New Zealand Government 2020) (e.g., proposed revisions to Section 3.21, “ground cover comprising more than 50% exotic pasture species”. See Appendix B). Additional enhancement would accrue if the wetland were restored by controlling willow growths and replanting with native wetland species. The quality of water entering the wetland could be improved by constructing wetlands to intercept each of the two major drain inputs from the lower terrace area (Figure 3-9) before they enter the natural wetland area.

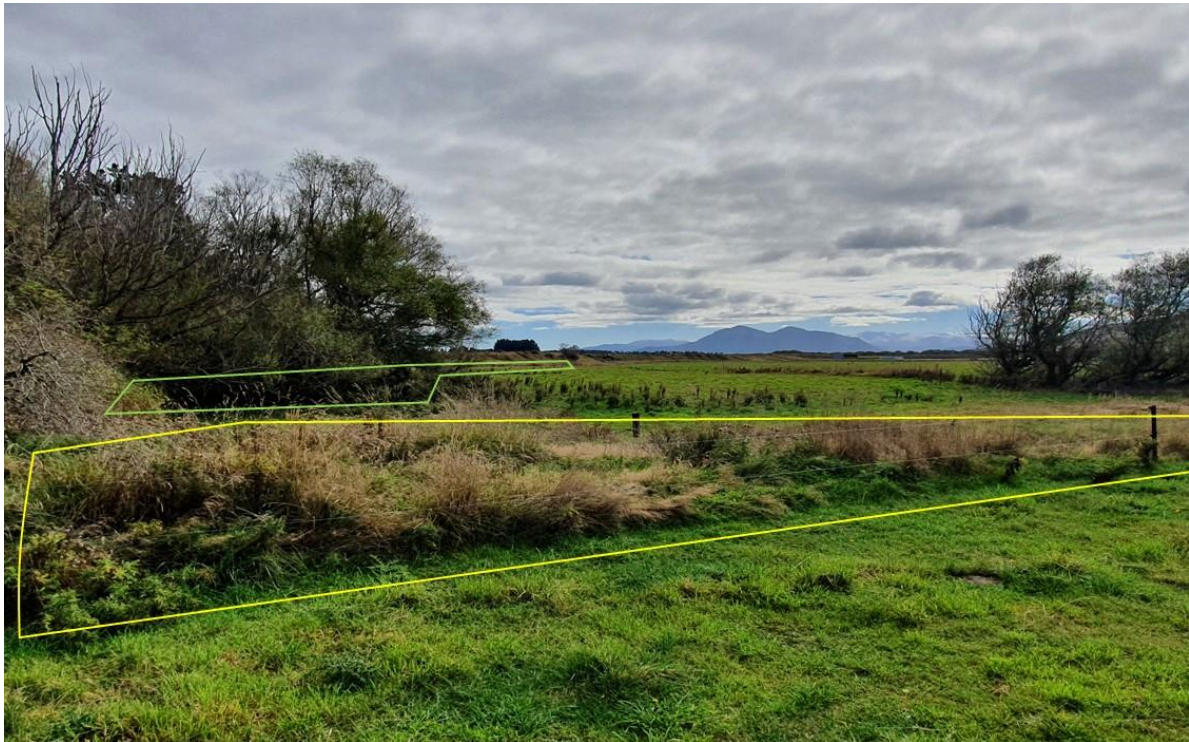
**Figure 3-9: Potential site for wetland restoration and riparian planting.** The area enclosed by the yellow polygon could be formed into a constructed wetland to treat the inflowing drain. The green polygon is around another input to the natural wetland that could be riparian planted. These areas are also shown in the same colours in Figure 3-10.

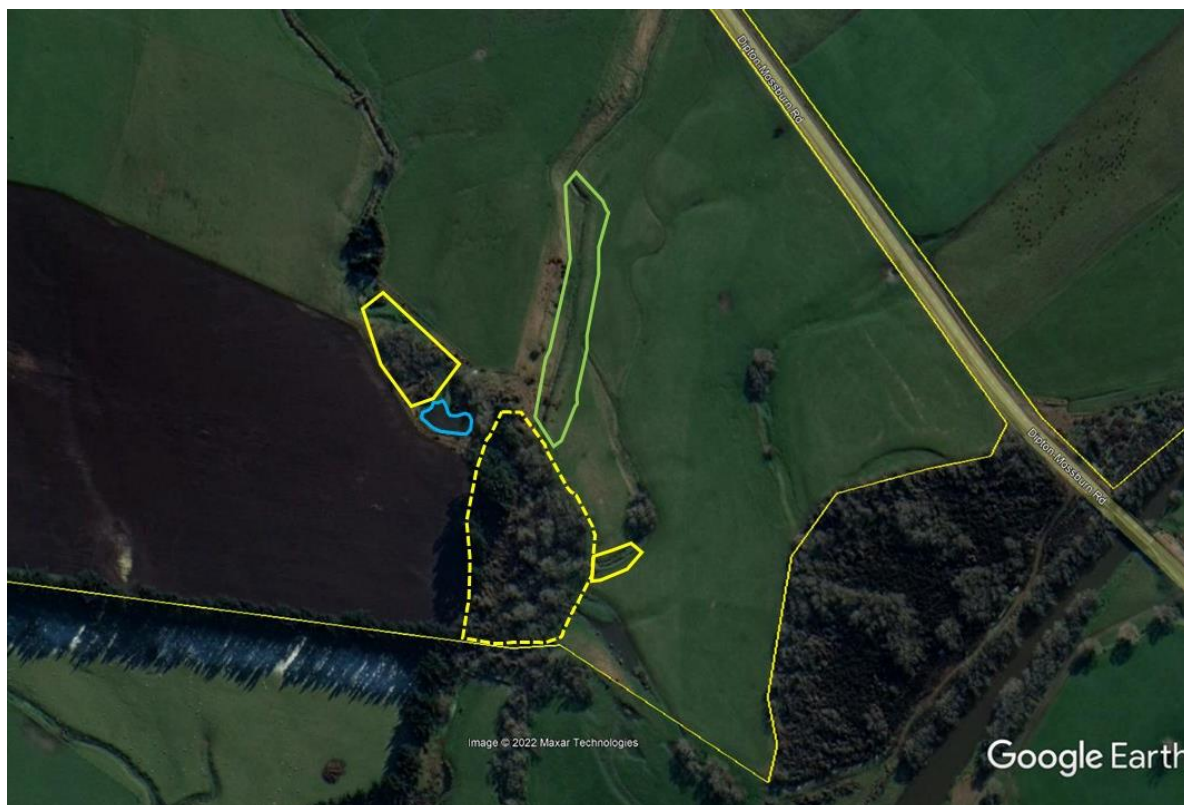
**Figure 3-10: Overview of potential options for willow-dominated wetland area and surroundings areas.** Potential wetland areas intercepting drain inflows are also shown in Figure 3-9.

**Preliminary remediation concept:** The existing willow wetland area is outlined with a dashed yellow line (Figure 3-10). Associated wetland areas that could also be enhanced or developed are shown

with solid yellow lines.

The pond is outlined in blue, and an area which could be enhanced by riparian planting is outlined in green. We propose that riparian planting and wetland creation occur only along feeder drains to this area (e.g., green bounded area in Figure 2-10) because modification of the existing wetland area will be difficult.

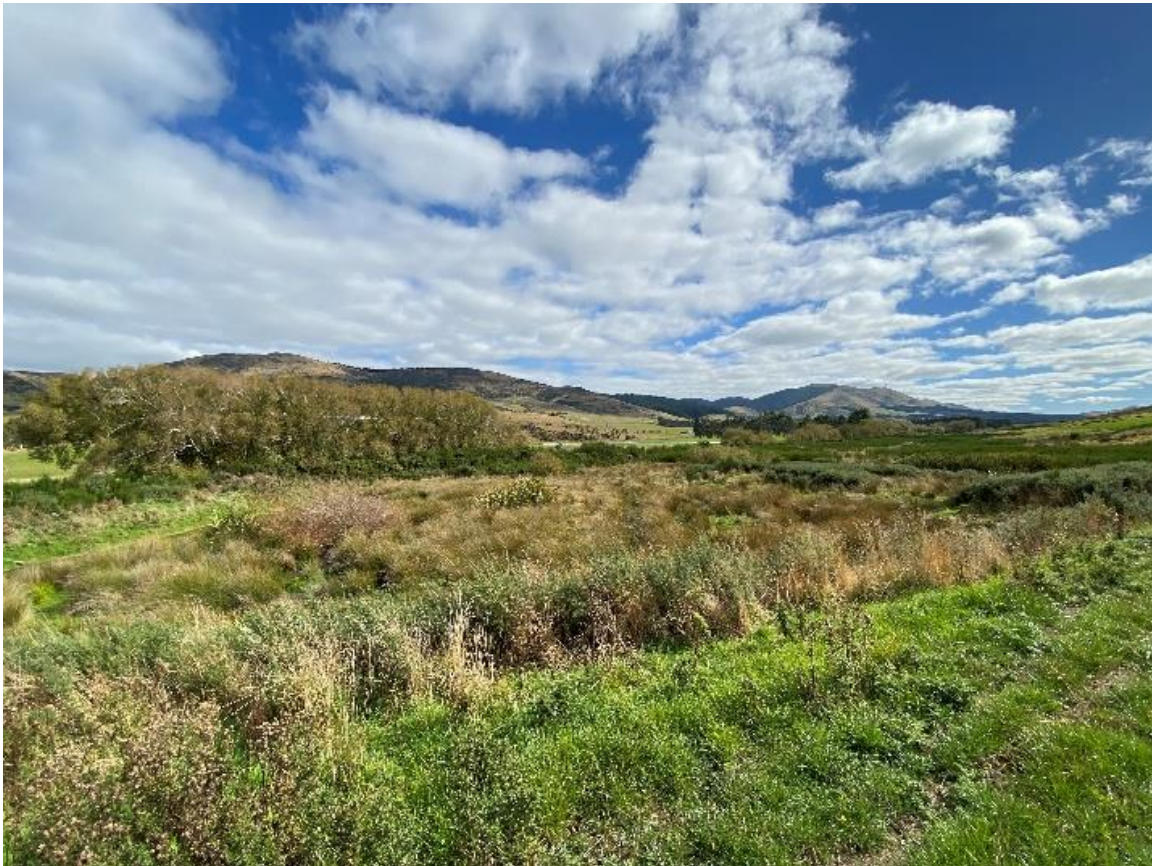
**Figure 3-12: Natural wetland undergoing restoration.**

**Site current status:** A natural wetland area (~3 ha) associated with an original meandering channel of Stagg Creek is being considered for rehabilitation. A stopbank between the current wetland area and Stagg Creek was probably created with spoil excavated when forming a linear channel for the creek. This wetland area receives flow from two surface drains and intercepts surface and subsurface run-off from upslope areas to the northwest of Stagg Creek, providing a relatively high wetland to catchment area ratio (>10%). The area remains wet for most of the year. There may also be potential for high-level flood-flows from the Creek to be reconnected into this area to increase natural water treatment.

The wetland is well fenced with large riparian margins. Nutrient inputs from contributing upper slopes are likely to be the prime pollutant to be addressed. Sediment and faecal bacteria inputs appeared to not be high, but should also be considered.

**Potential site re-development:** The current landowner(s) have impounded the outlet of this previously drained area, allowing reflooding and redevelopment of the wetland character of this site, including a large area of open water close to the outlet. They suggested creating a bund further up the catchment to create a 2 or 3 step wetland (Note: the Google Earth image to the left was from 2017; further drainage seems to have occurred after this, prior to current restoration efforts). The owners' vision for the site was well developed and appeared appropriate to the situation. Information on suitable plants likely to have been present in the original wetland/stream complex (e.g., flaxes, kahikatea, cabbage trees, tussocks, raupo, spike sedges, *Carex* species) would help to

guide rehabilitation of this area. Herbicide pretreatment of the site (potentially twice) would assist with removal of extensive areas of broom and gorse and allow better establishment of wetland and riparian plantings.

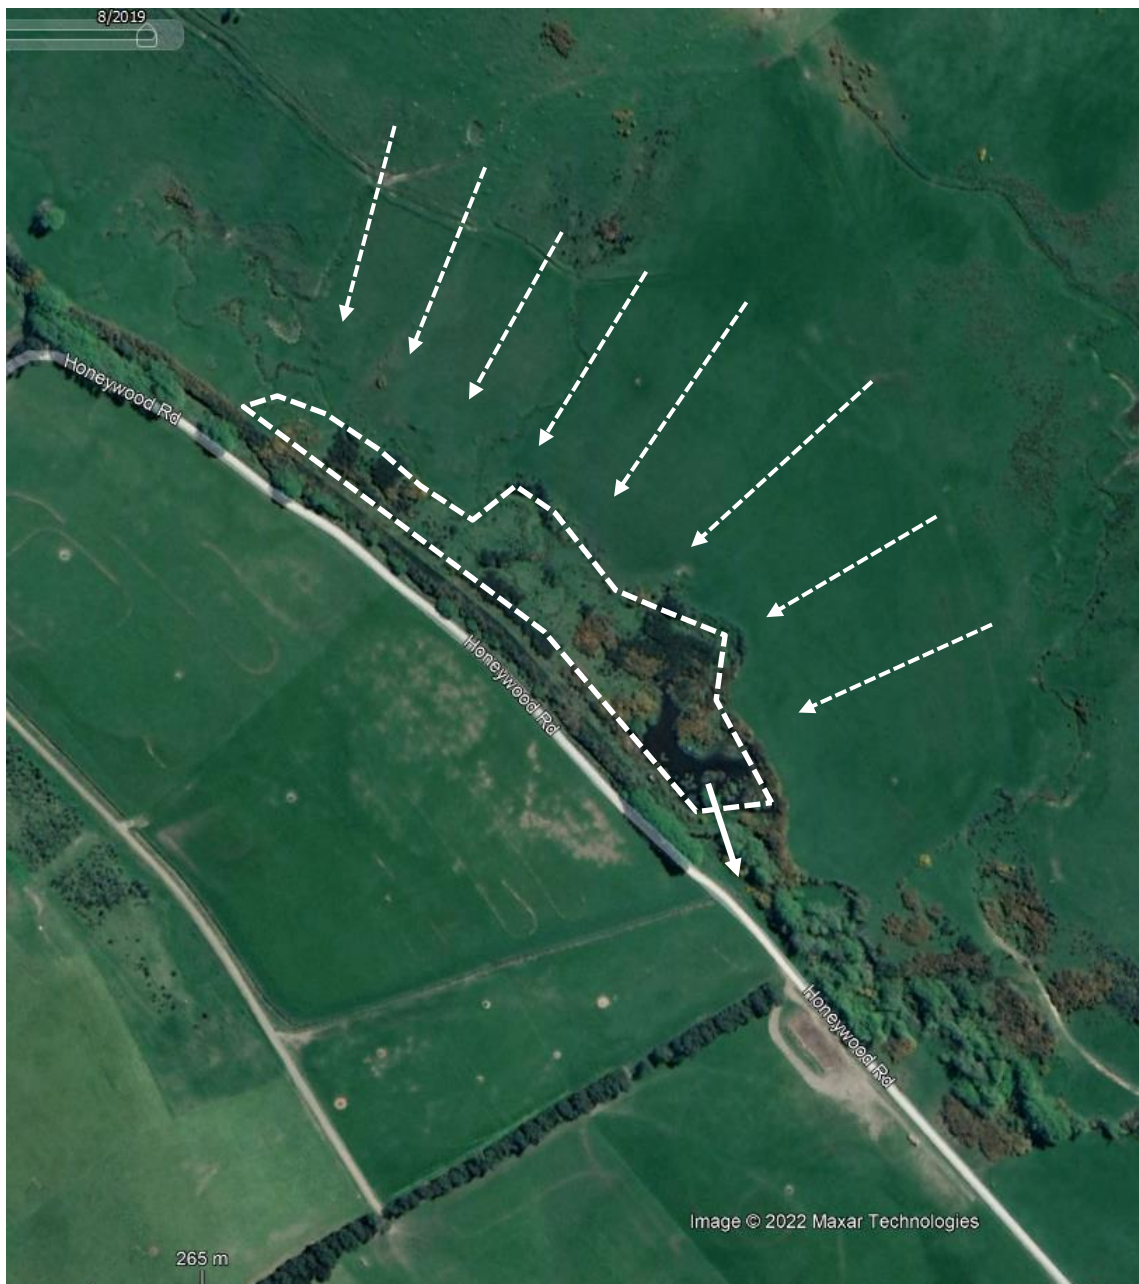
**Preliminary remediation concept:** Figure 3-13 shows the approximate area proposed for wetland restoration by the current landowner. Creating some low earth bunds in strategic locations within the wetland may assist to maintain suitable water levels in the wetland to enhance contaminant removal. It will also help create a more diverse range of open water and shallow zones, increasing the range of wetland environments provided and resultant biodiversity in the area. Significant parts of the area would likely be considered natural wetlands under the RMA, and subject to the new wetland protection measures in the NPS-FM. Although the actions proposed are primarily aimed at restoration and rehabilitation of the wetland, the regional council will need to be contacted to determine consenting requirements, in particular for any earthworks involved.

**Figure 3-13: Overview of wetland area currently undergoing restoration, parallel to Stag Creek.** Flows from slopes to the northeast of the wetland (white-dashed arrows) are assumed to be intercepted in the wetland and then flow southeast through the wetland alongside the stream before discharging into the stream at the point indicated by the solid arrow.

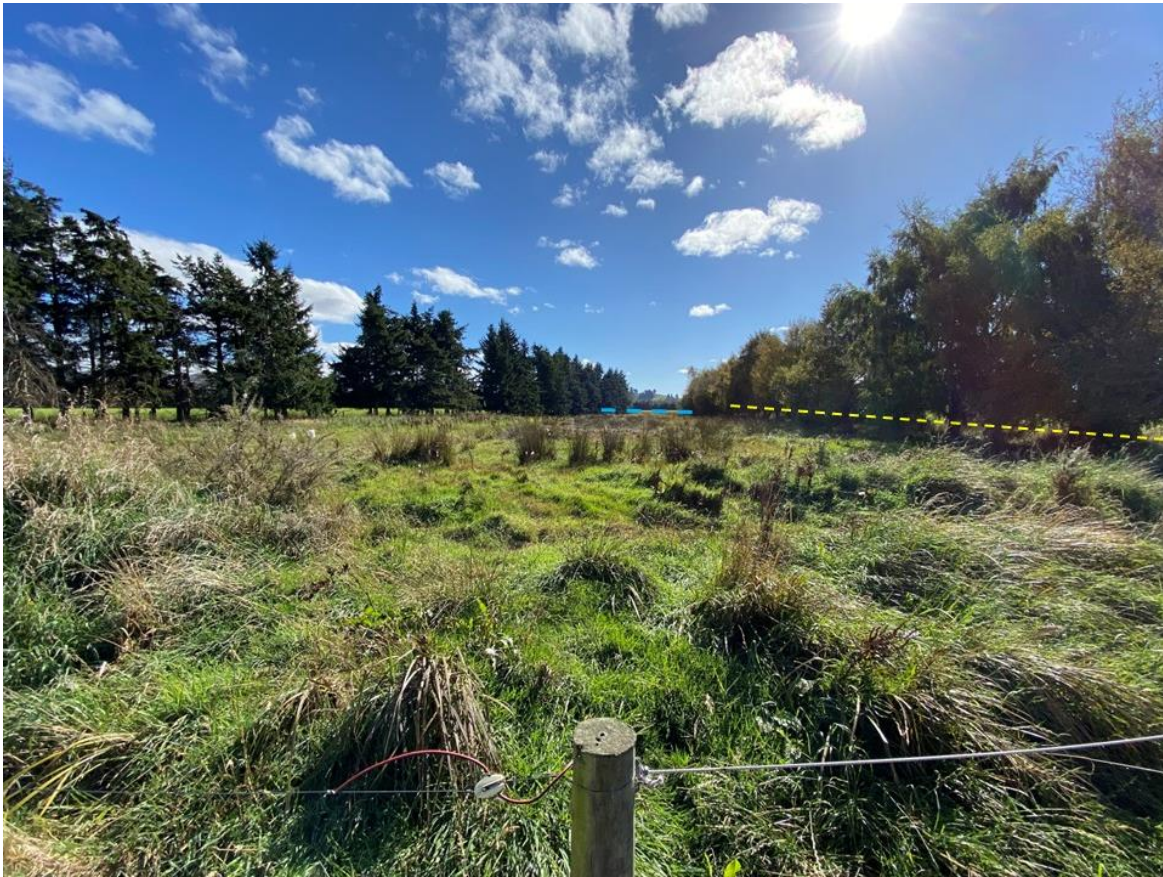
**Figure 3-15: Potential wetland site.** The area has boggy soils and retains some wetland characteristics. This may trigger the NPS-FM status as a natural wetland. A large drain runs down the outside of the trees to the right (yellow dashed line). Dipton Castlerock Road location shown with blue dashed line.

**Site current status:** The site is a soft and boggy wetland swale, with a very shallow water table. Pasture grasses and some remnant rushes, *Carex* species and other wetland species, vegetate the site. Most flow either enters from the area to the left of the trees, or from the far end (close to the Dipton Castlerock Road). The current organic soils and wetland character will likely be providing significant treatment of any water entering the wetland swale.

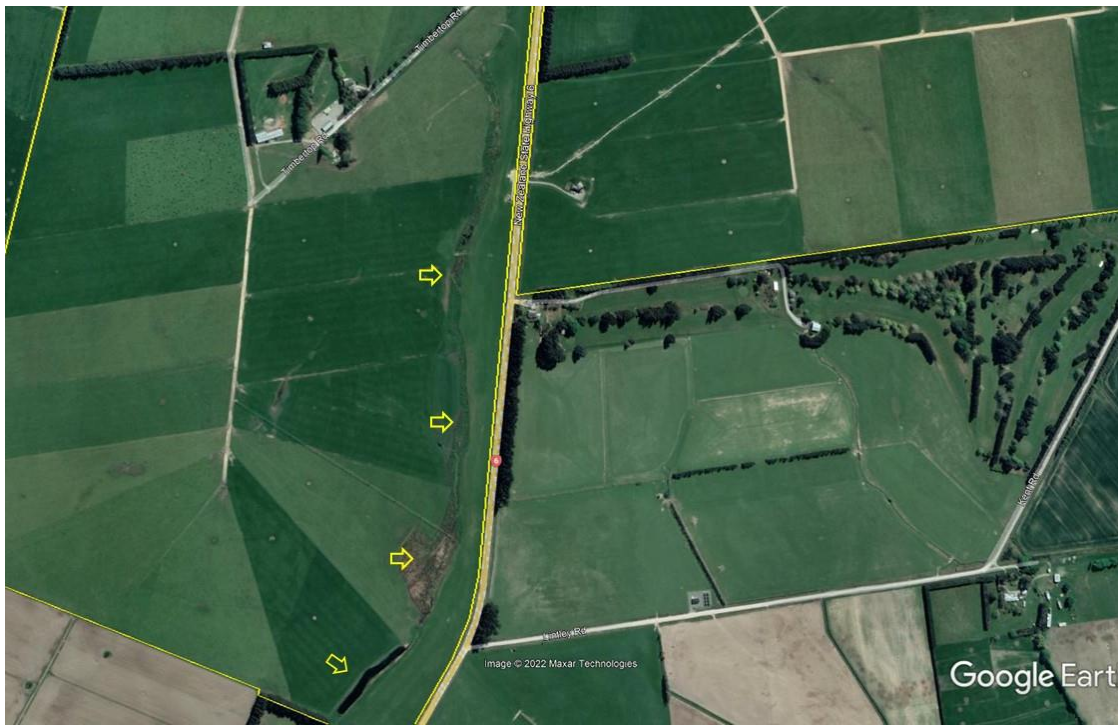
**Figure 3-17: Close up satellite image showing wetland swale and pond.** The swale runs from north to south, with the deeper pond at the southernmost end. Site location  $\sim 45^{\circ}46'49.82''$  S  $168^{\circ}26'34.92''$  E.

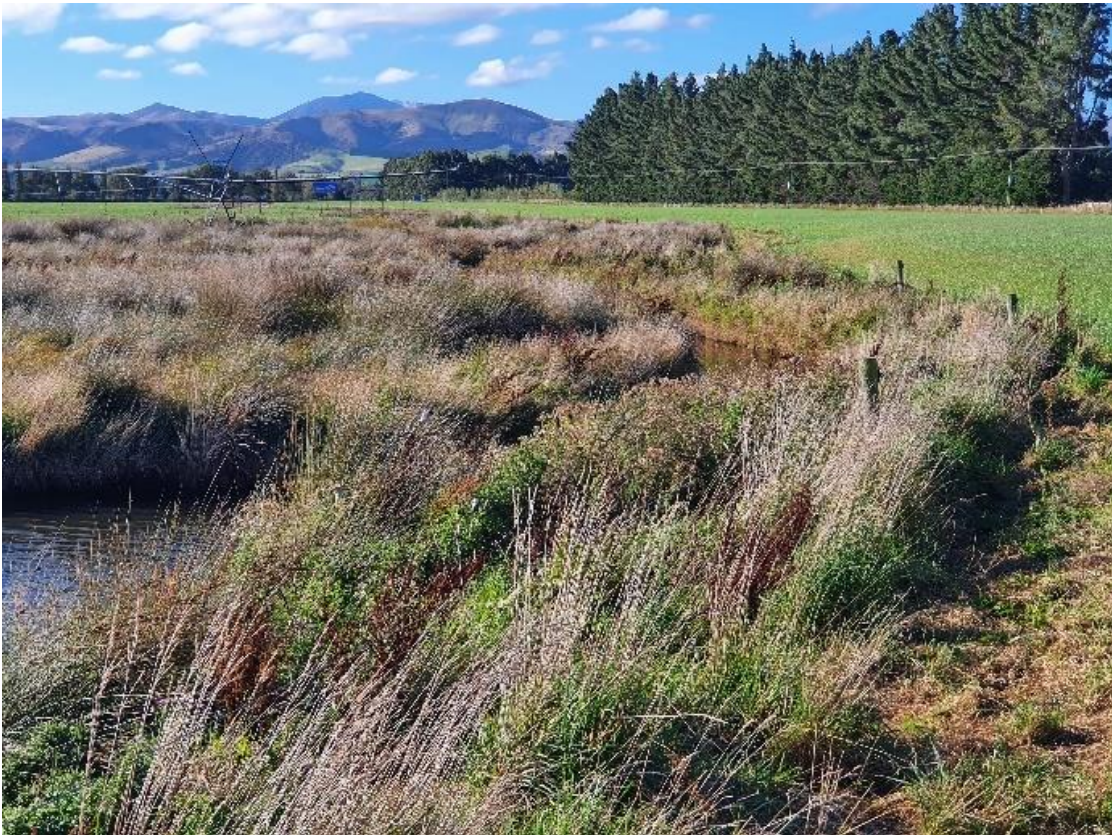
**Figure 3-18: View looking north along the swale.** Natural, but somewhat degraded, wetland vegetation is present in much of the area visible.

**Site current status:** The area is a natural wetland swale running through a paddock along the base of a short incline. The swale occupies an area of about 4 ha, is 1.8 km long and varies in width from 5 m to 30 m. At the outflow end, the area has been used as a gravel extraction pit which has now become a deep pond. The area has been fenced off from surrounding paddocks for c.14 years, but previously had been grazed by deer, resulting in loss of some wetland vegetation and ingress of wet-tolerant pasture species. The fence is set 2-3 m back from the water's edge around most of the swale area, giving potential for riparian planting, but it is much closer to the water's edge (c.1 m) around the pond/gravel extraction pit area.

Past gravel extraction has created a pond area with relatively steep sides, which are currently not suitable for establishment of emergent wetland plants.

**Preliminary remediation concept:** Potential recontouring of the gravel extraction pond areas, if permissible, to incorporate shallow benched margins would allow planting with native emergent wetland species to enhance water quality in the pond and provide improved treatment of lateral inputs. Potential planting zones are shown in Figure 3-19. However, to assess this option we have limited our proposed action to weed control and planting of the wetland swale.

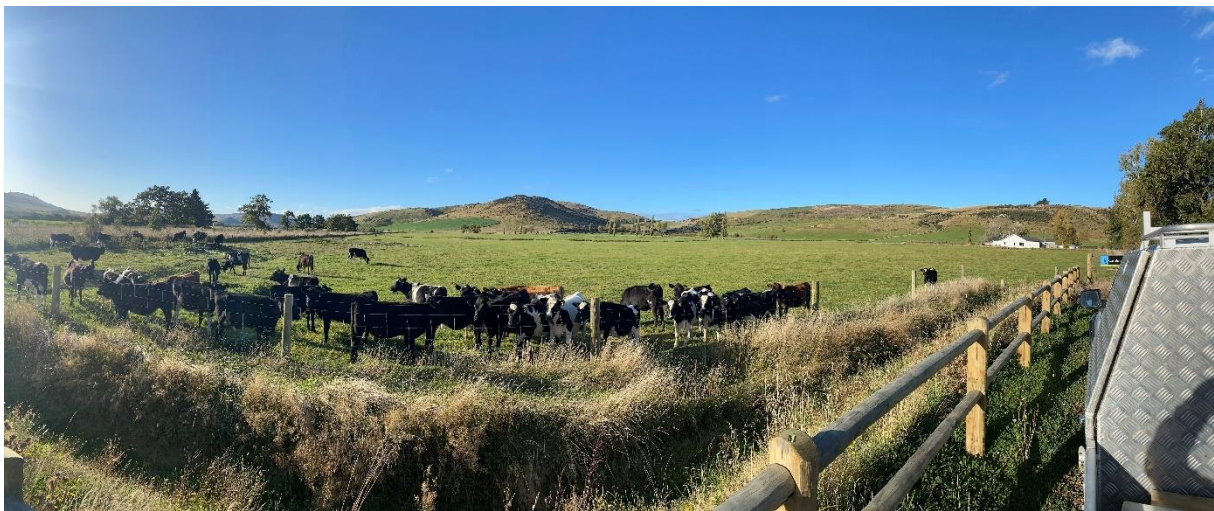
**Figure 3-22: Farm view of proposed wetland site.** The proposed wetland area is on the left side of the photo.

**Site current status:** The site is in a corner of a paddock which becomes difficult to manage during wet weather.

As the site is usually above the existing water table, maintaining a wetland character year-round at this site will require excavation of the site down to the water table. Surface or subsurface drains could be used to route overland flow from most of the paddock into the proposed wetland area. The owner proposes to create a complex of deeper areas and shallow areas in the wetland, and using some of the excavated material to create islands for biodiversity and amenity value.
