CASE STUDY

Russell Drummond Aparima River Catchment

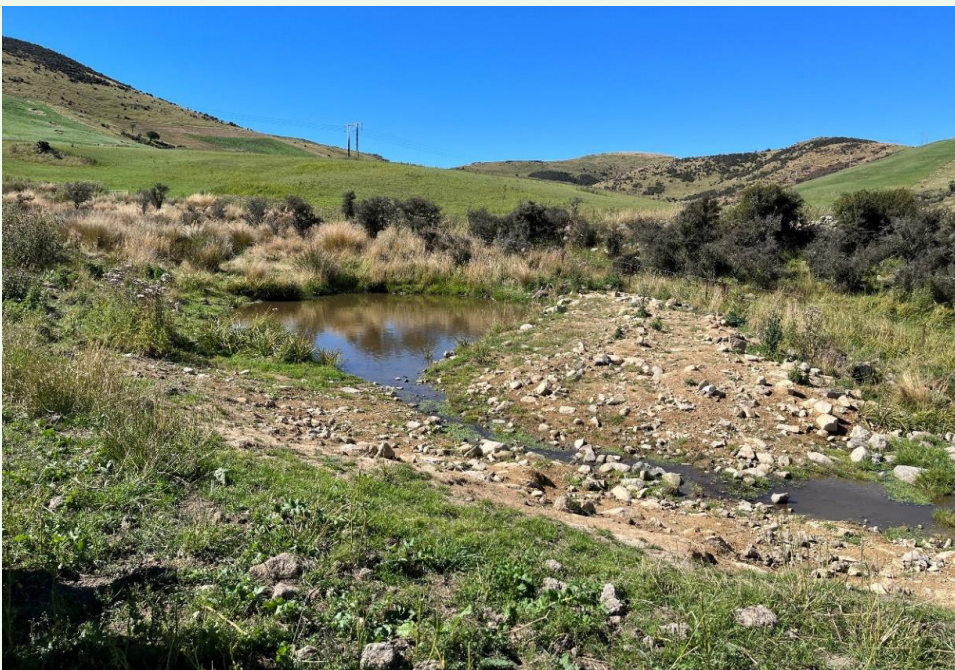
Image 1: A bund has been placed to slow water flow allowing sediment to settle. The outlet is located to the side of the structure to ensure flow is disrupted and minimise the risk of blow out.

This sediment trap has been constructed by creating a bund in an existing gully system. The catchment area above this site consists of developed pasture with periodic winter grazing. This sediment trap aims to slow overland flow to allow sediment and phosphorus to drop from suspension during rainfall events.

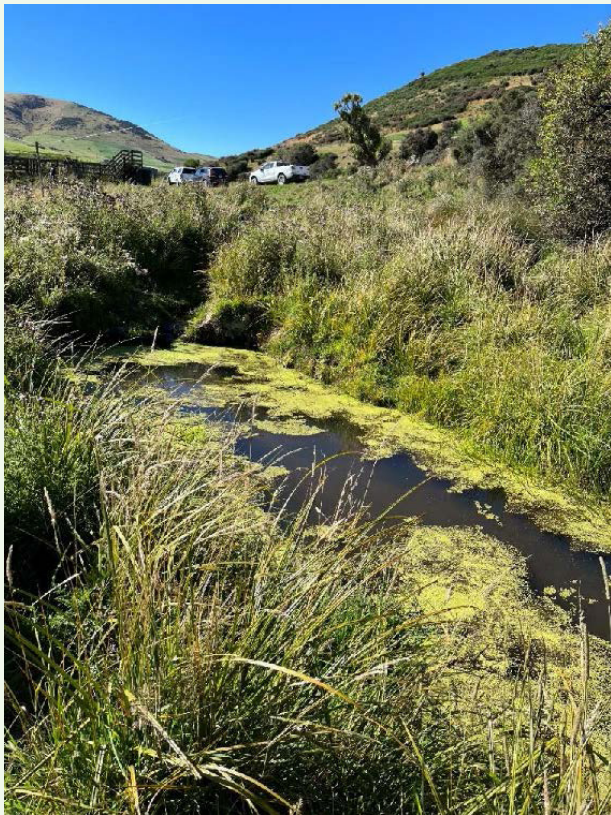
Image 2: The second sediment trap area in a series of two. Water movement through this sediment trap is slow. Discharge from the outflow flows over a heavily vegetated area before reaching an adjacent stream.

Site two is located in a vegetated critical source area. A series of two traps of about 10 x 1 x 1 meters have been created. Scrub and pasture species surround the area assisting with the filtration/capture of sediment during rainfall.

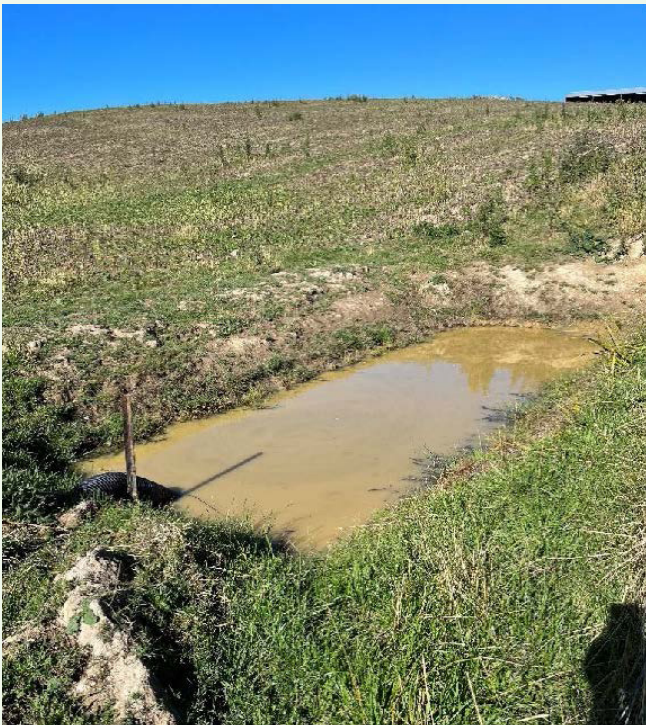
Image 3: The recently constructed sediment trap located next to a main access track. Track runoff flows into the top of the trap allowing the velocity to slow and sediment to drop out before flowing out via a tile drain. This image was taken after recent rain with evidence of finer sediments still suspended in the water.

Site three is located next to an existing access track to intercept sediment moving down the access track into a waterway. The trap has been constructed to a size approximately 10 meters long, x 2 meters wide and x 1 meter deep.

Due to the catchment area being a track with little to no vegetation cover this trap will require regular emptying to remain effective.
