Russell Drummond – Aparima River Catchment

The Drummond property is an extensive sheep and beef operation located at Avondale within the Upper Aparima River Catchment. The topography of the property is rolling to steep with some areas of river flat.

On advice from Environment Southland, Russell has constructed four sediment traps on his property, each focusing on separate smaller catchment areas.

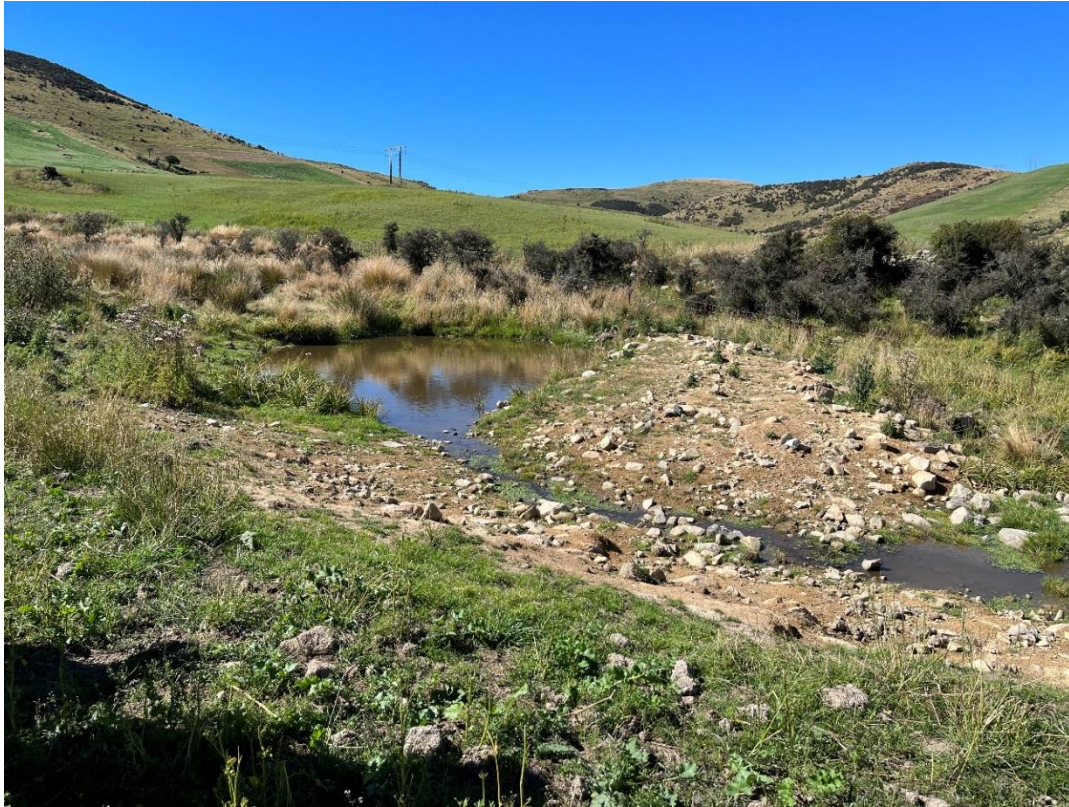
Site 1

*Image 1:
A bund has been placed to slow water flow allowing sediment to settle. The outlet is located to the side of the structure to ensure flow is disrupted and minimise the risk of blow out.*

This sediment trap has been constructed by creating a bund in an existing gully system. The catchment area above this site consists of developed pasture with periodic winter grazing. This sediment trap aims to slow overland flow to allow sediment and phosphorus to drop from suspension during rainfall events.

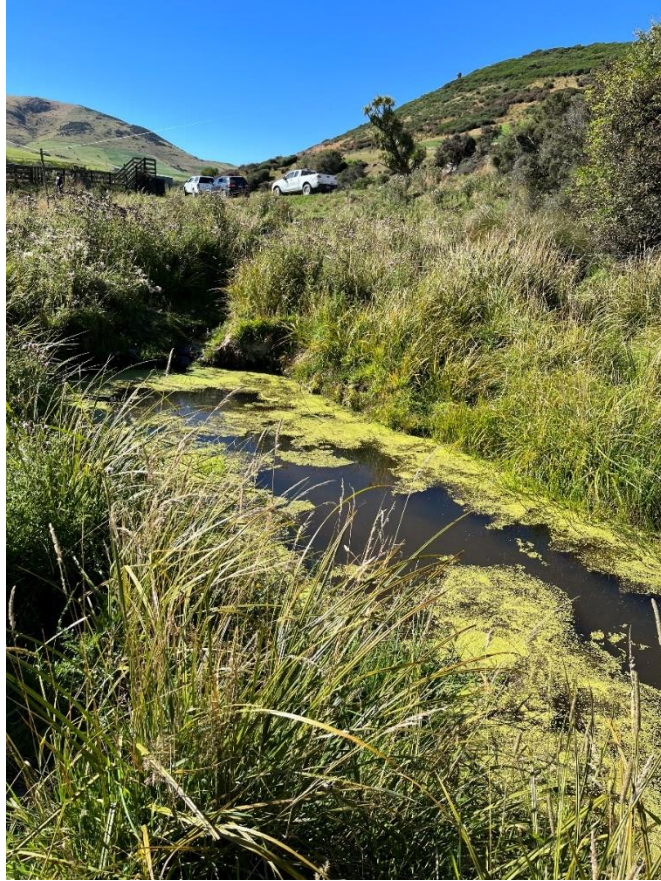
Site Two

Image 2: The second sediment trap area in a series of two. Water movement through this sediment trap is slow. Discharge from the outflow flows over a heavily vegetated area before reaching an adjacent stream.

Site two is located in a vegetated critical source area. A series of two traps of about 10 x 1 x 1 meters have been created. Scrub and pasture species surround the area assisting with the filtration/capture of sediment during rainfall.

Table 1: Key calculations of Site 2 sediment trap. Note in this illustrative example the fenced off area is included as a wetland treatment area within the catchment and the actual physical sediment traps are a small treatment that complement the vegetated areas. Reductions are based on the NIWA constructed wetland guidelines which rely on treatment relative to catchment size.

Catchment area	19ha (19,000 m ²)
Fenced off area	0.672ha (6720 m ²)
Sediment traps size (x4)	10 x 1 x 1m (40m ²)
Effective wetland area % of catchment	3.5% (6720/19000)
% of N reduced	35%
% of P stored	45 %
% of sediment collected	80 %

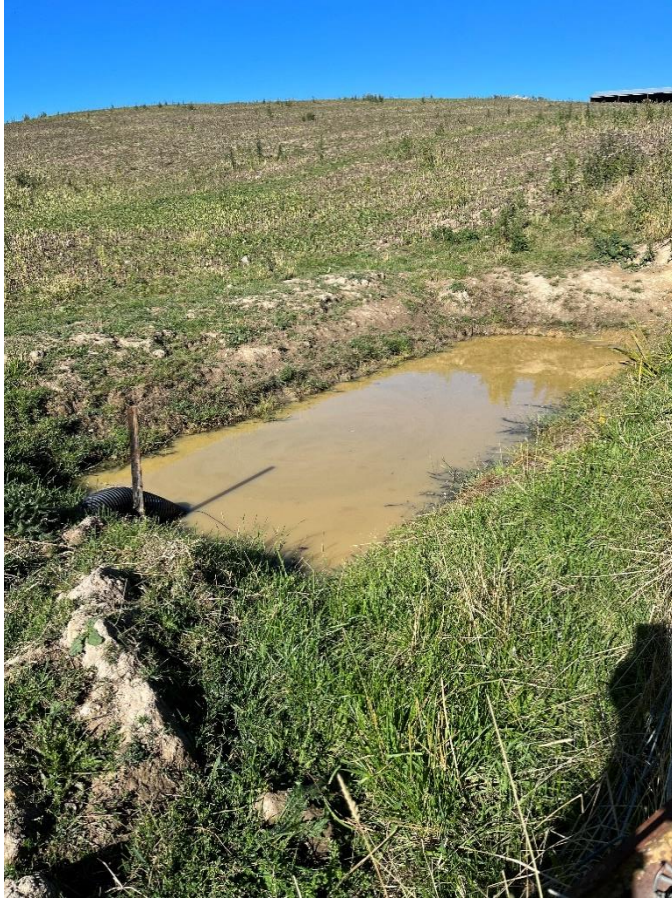
Site Three

Image 3: The recently constructed sediment trap located next to a main access track. Track runoff flows into the top of the trap allowing the velocity to slow and sediment to drop out before flowing out via a tile drain. This image was taken after recent rain with evidence of finer sediments still suspended in the water.

Site three is located next to an existing access track to intercept sediment moving down the access track into a waterway. The trap has been constructed to a size approximately 10 meters long, x 2 meters wide and x 1 meter deep.

In time the sediment trap will be permanently fenced to exclude stock and planted with native grasses to aid in the capture of further sediment and nutrients from both the sediment trap and a critical source area located adjacent to the sediment trap.

The catchment area of this portion of track is about 0.252ha (2520m² or a 50m*50m square). Environment Southland have calculated that over a year, it is likely to be transporting over 2.2 million liters of water containing track sediments that will contain bacteria and nutrients. (2520m² * 900mm annual rainfall)

Due to the catchment area being a track with little to no vegetation cover this trap will require regular emptying to remain effective.
